制造工程师问题汇总：

2010-8-19 培训发现：

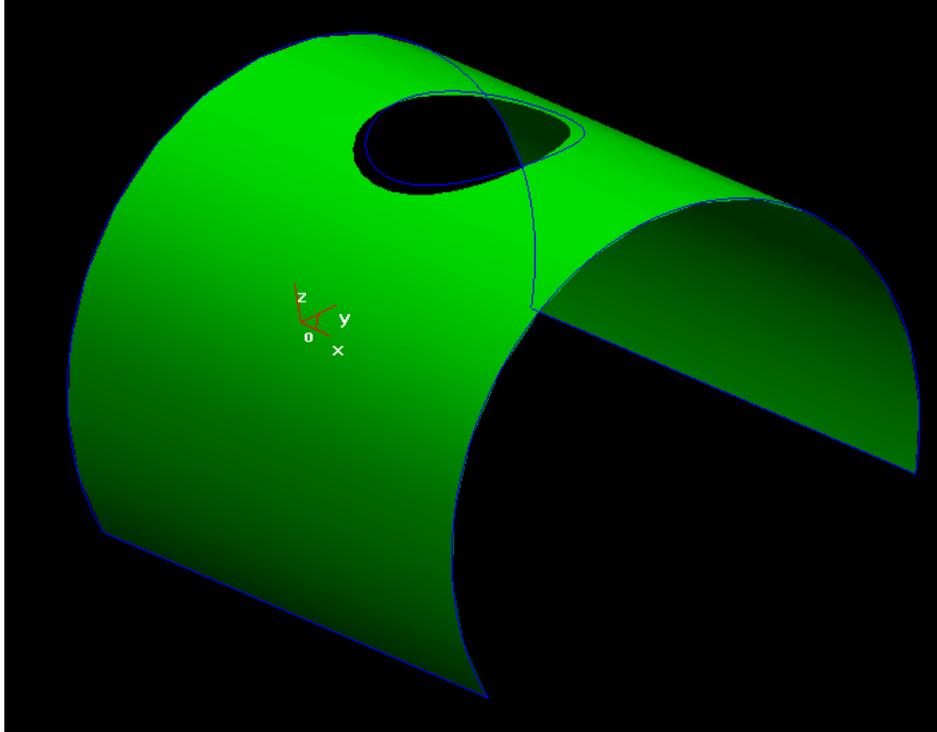
1、五轴参数线加工的元素不能为裁剪曲面（只能是完整的曲面，中间不能出现断裂或者空）。

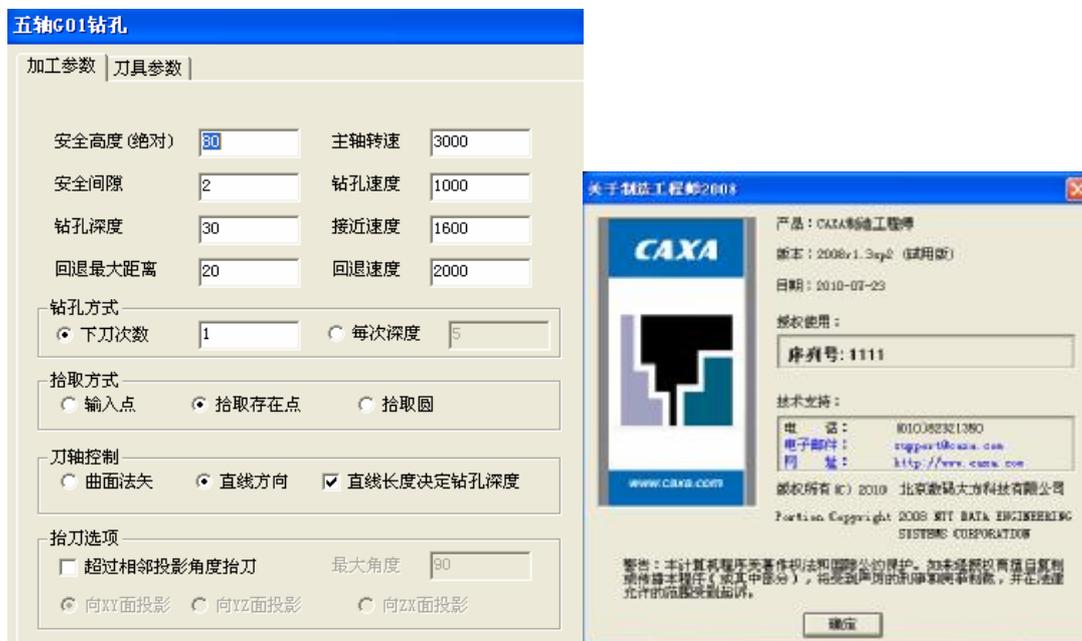
2、五轴 G01 钻孔的“直线长度决定钻孔深度”无效，之前的版本可以使用的。

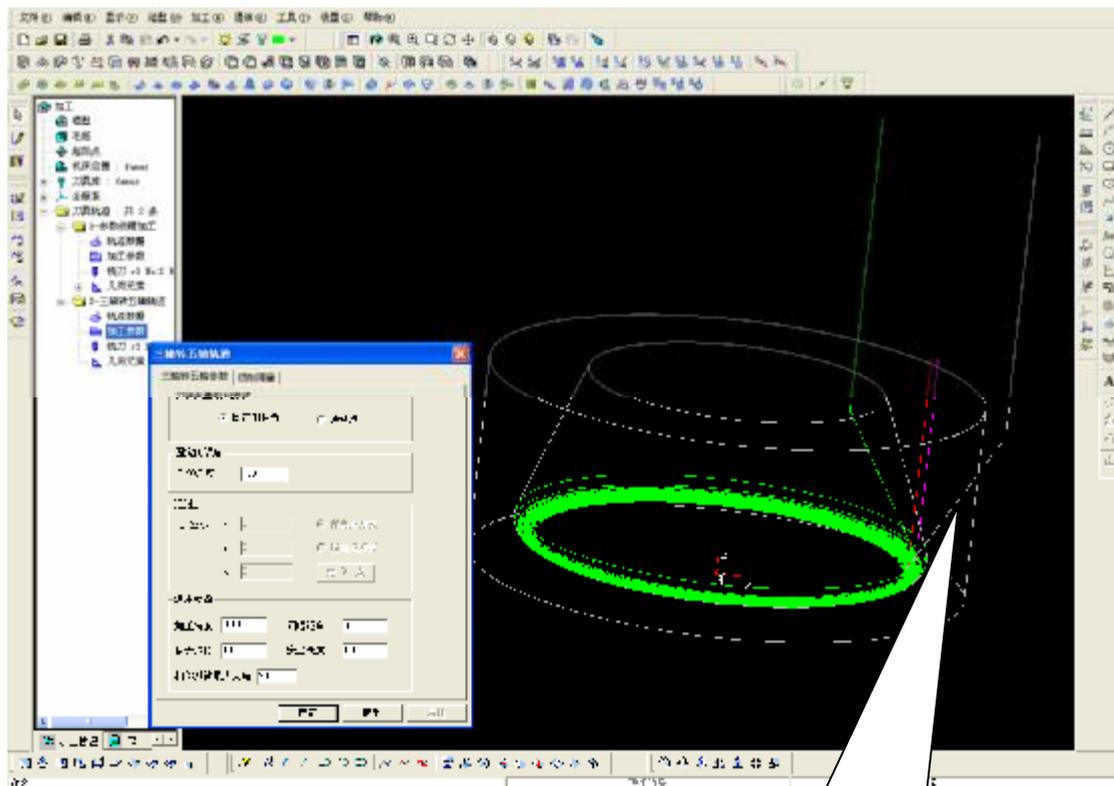
3、3轴转5轴的退刀过切。

此退刀线由实体中间出来。应与进刀角度线一致。

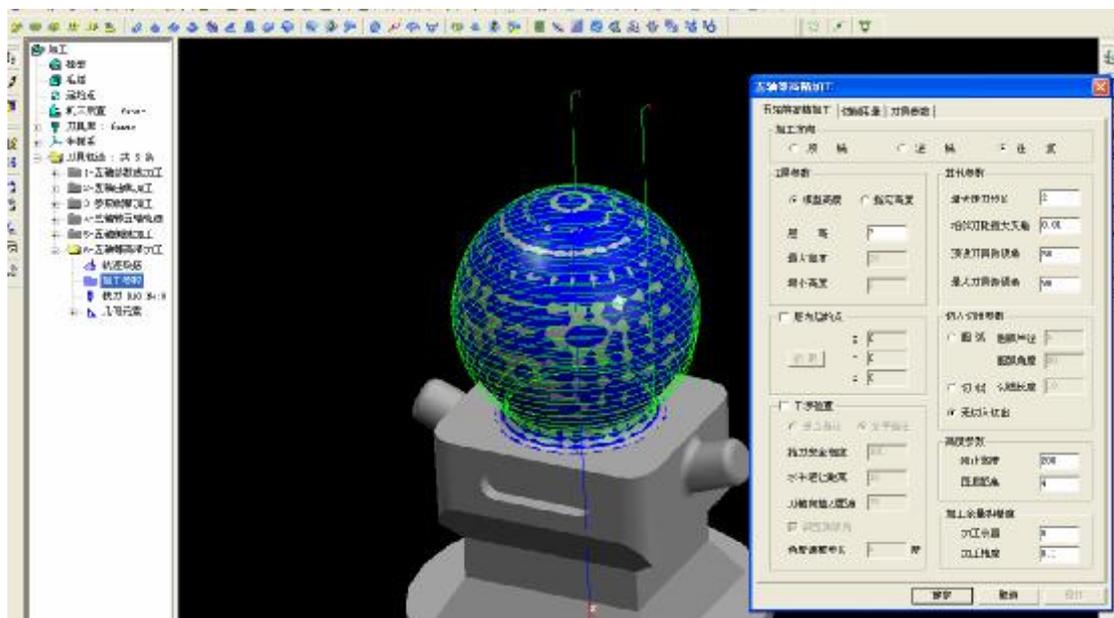
4、五轴等高加工

(1) 生成速度超慢

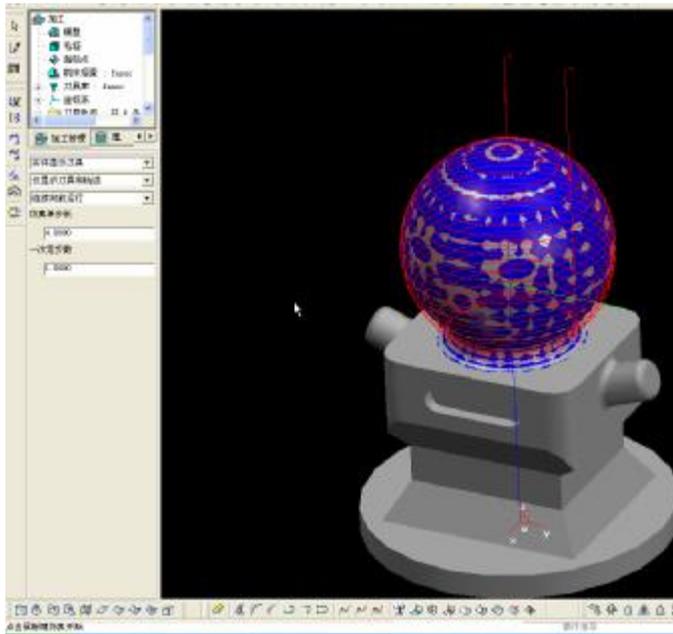
(2) 线框仿真慢到接近死机状态。

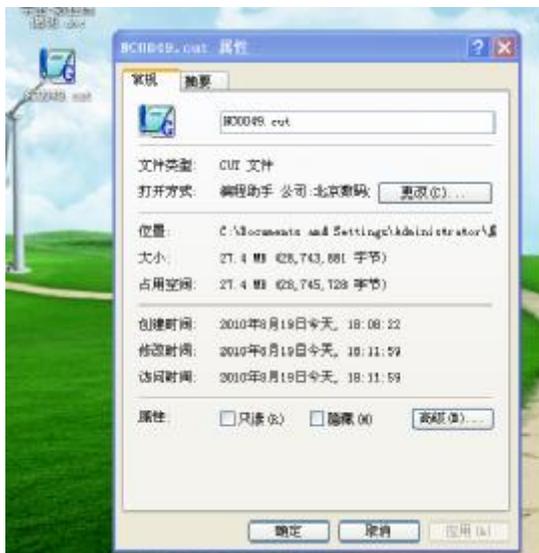
(3) 10 行的轨迹竟然有 27.4 M 的代码?!
